# Choosing the Right Metal for Masonry Flashing

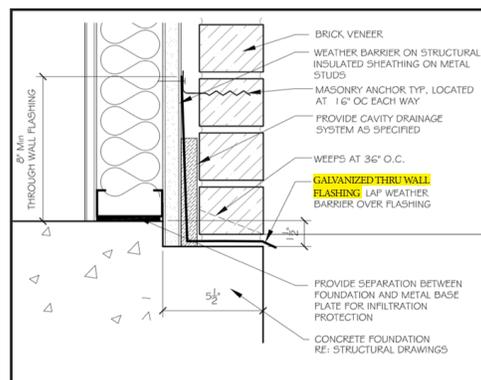
*Detail calls out galvanized steel as the through-wall-flashing. When installed this way the flashing will rust and fail.*

To the right is an example of a galvanized steel detail and a picture of the constructed wall. The failure of the flashing occurred before the construction of the job was completed.

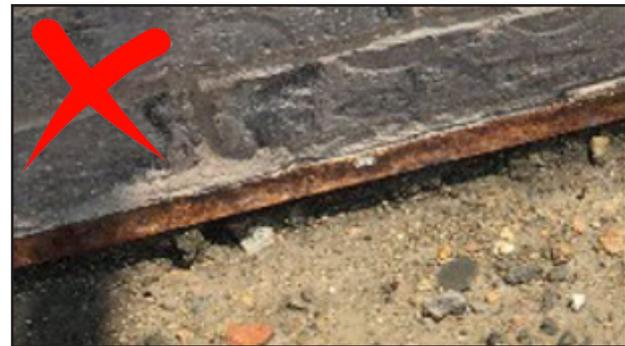
*Example of a rusted drip edge that has failed*

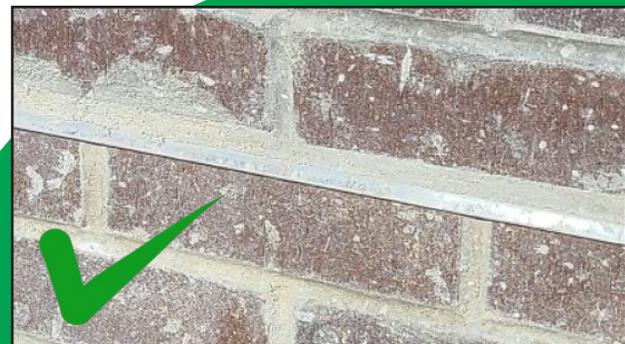
*Example of a Type 304 stainless steel drip edge*
